**AFRL-VA-WP-TR-2001-3004**

**DC-9 AFT PRESSURE BULKHEAD  
RESIDUAL STRENGTH TEST**

**FINAL REPORT FOR PERIOD OF 01 JUNE 1999 – 01 APRIL 2000**

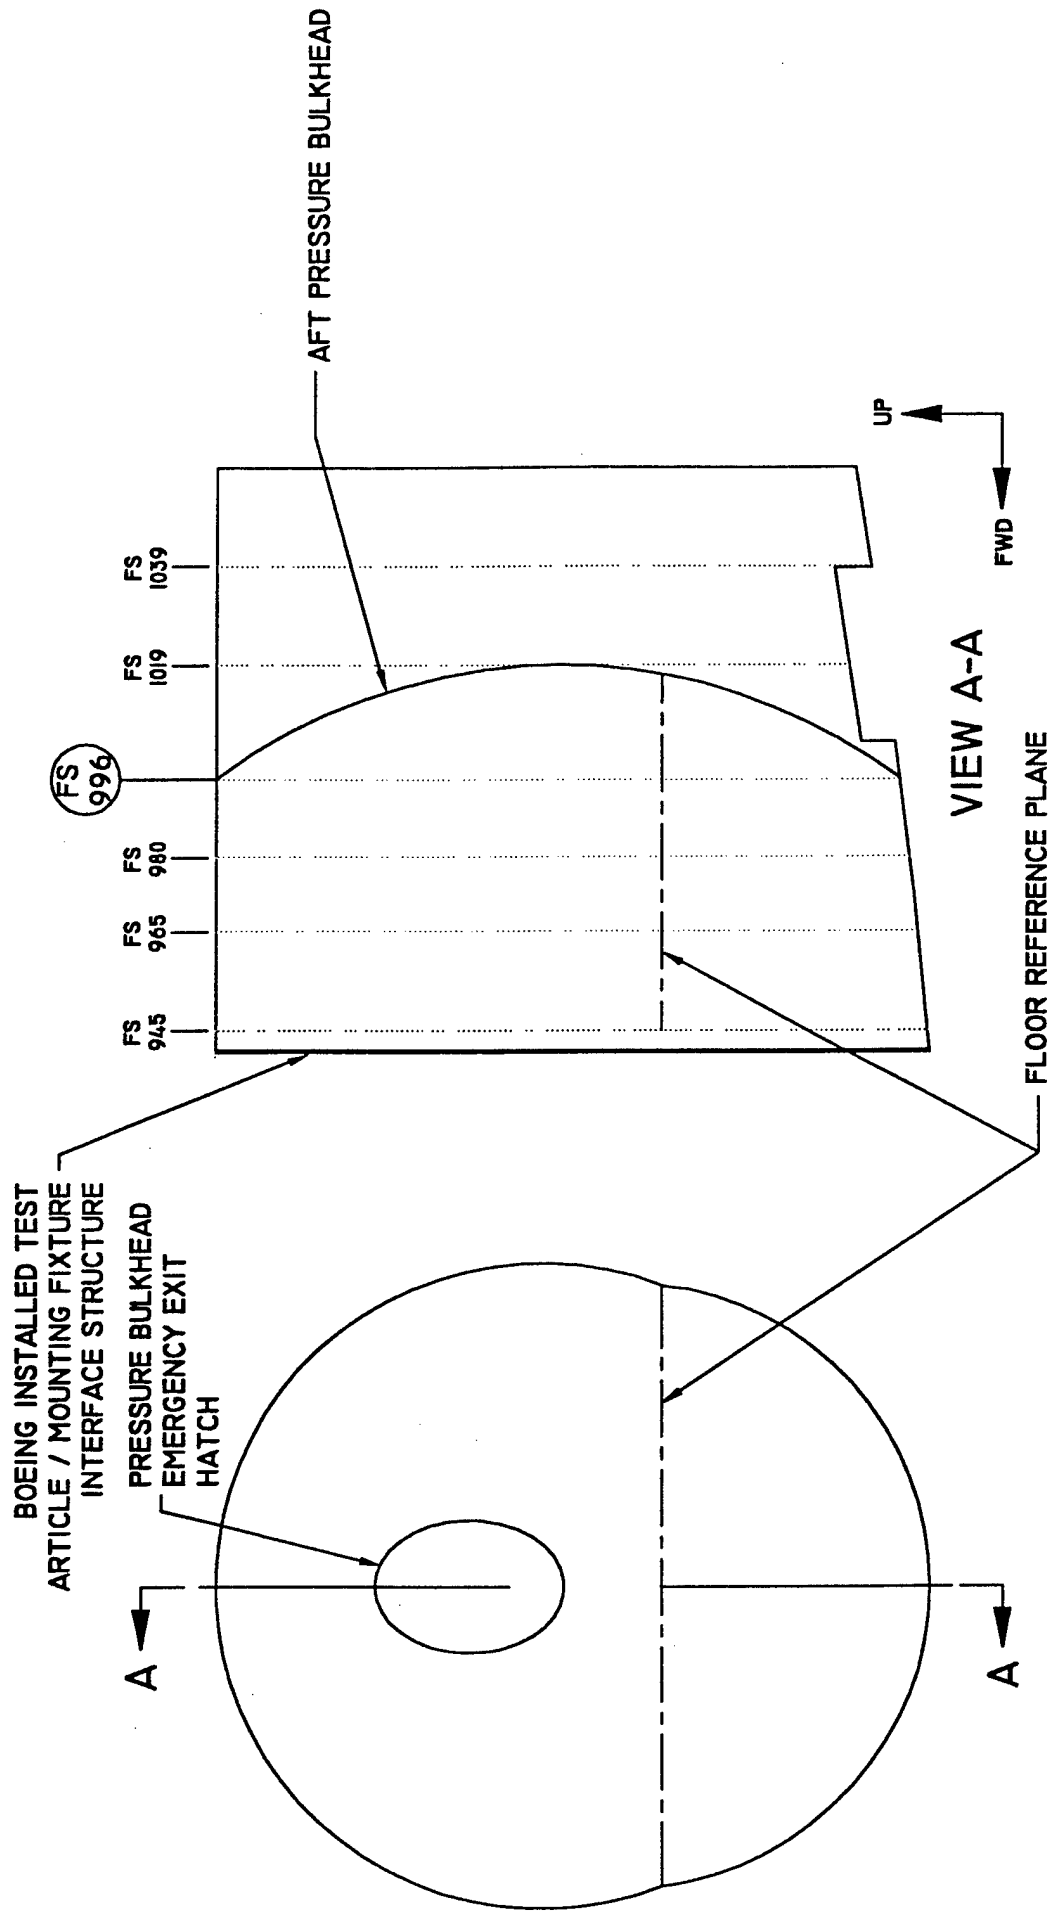
Figure 1. Aft Pressure Bulkhead Test Specimen

The test article was approximately the aft 10 feet of a DC-9 fuselage incorporating the aft pressure bulkhead (Figure 1). This particular aircraft had 57,757 landings and 60,583 flight hours. When mounted on a fixture plate, the enclosed volume was approximately 700 ft<sup>3</sup>. The test article preparation by Boeing included a) cutting the fuselage section to a manageable size, b) installing a structure forward of the bulkhead to facilitate mounting the test article and c) creating the MSD and lead crack in the pressure web (Figures 2 and 3). The AFRL/VASV at Building 65, WPAFB received the prepared test article and mounted it to a fixture plate fabricated locally. Government technicians installed all instrumentation and completed the mechanical, electrical and pneumatic systems installations as required (Figures 4 and 5).

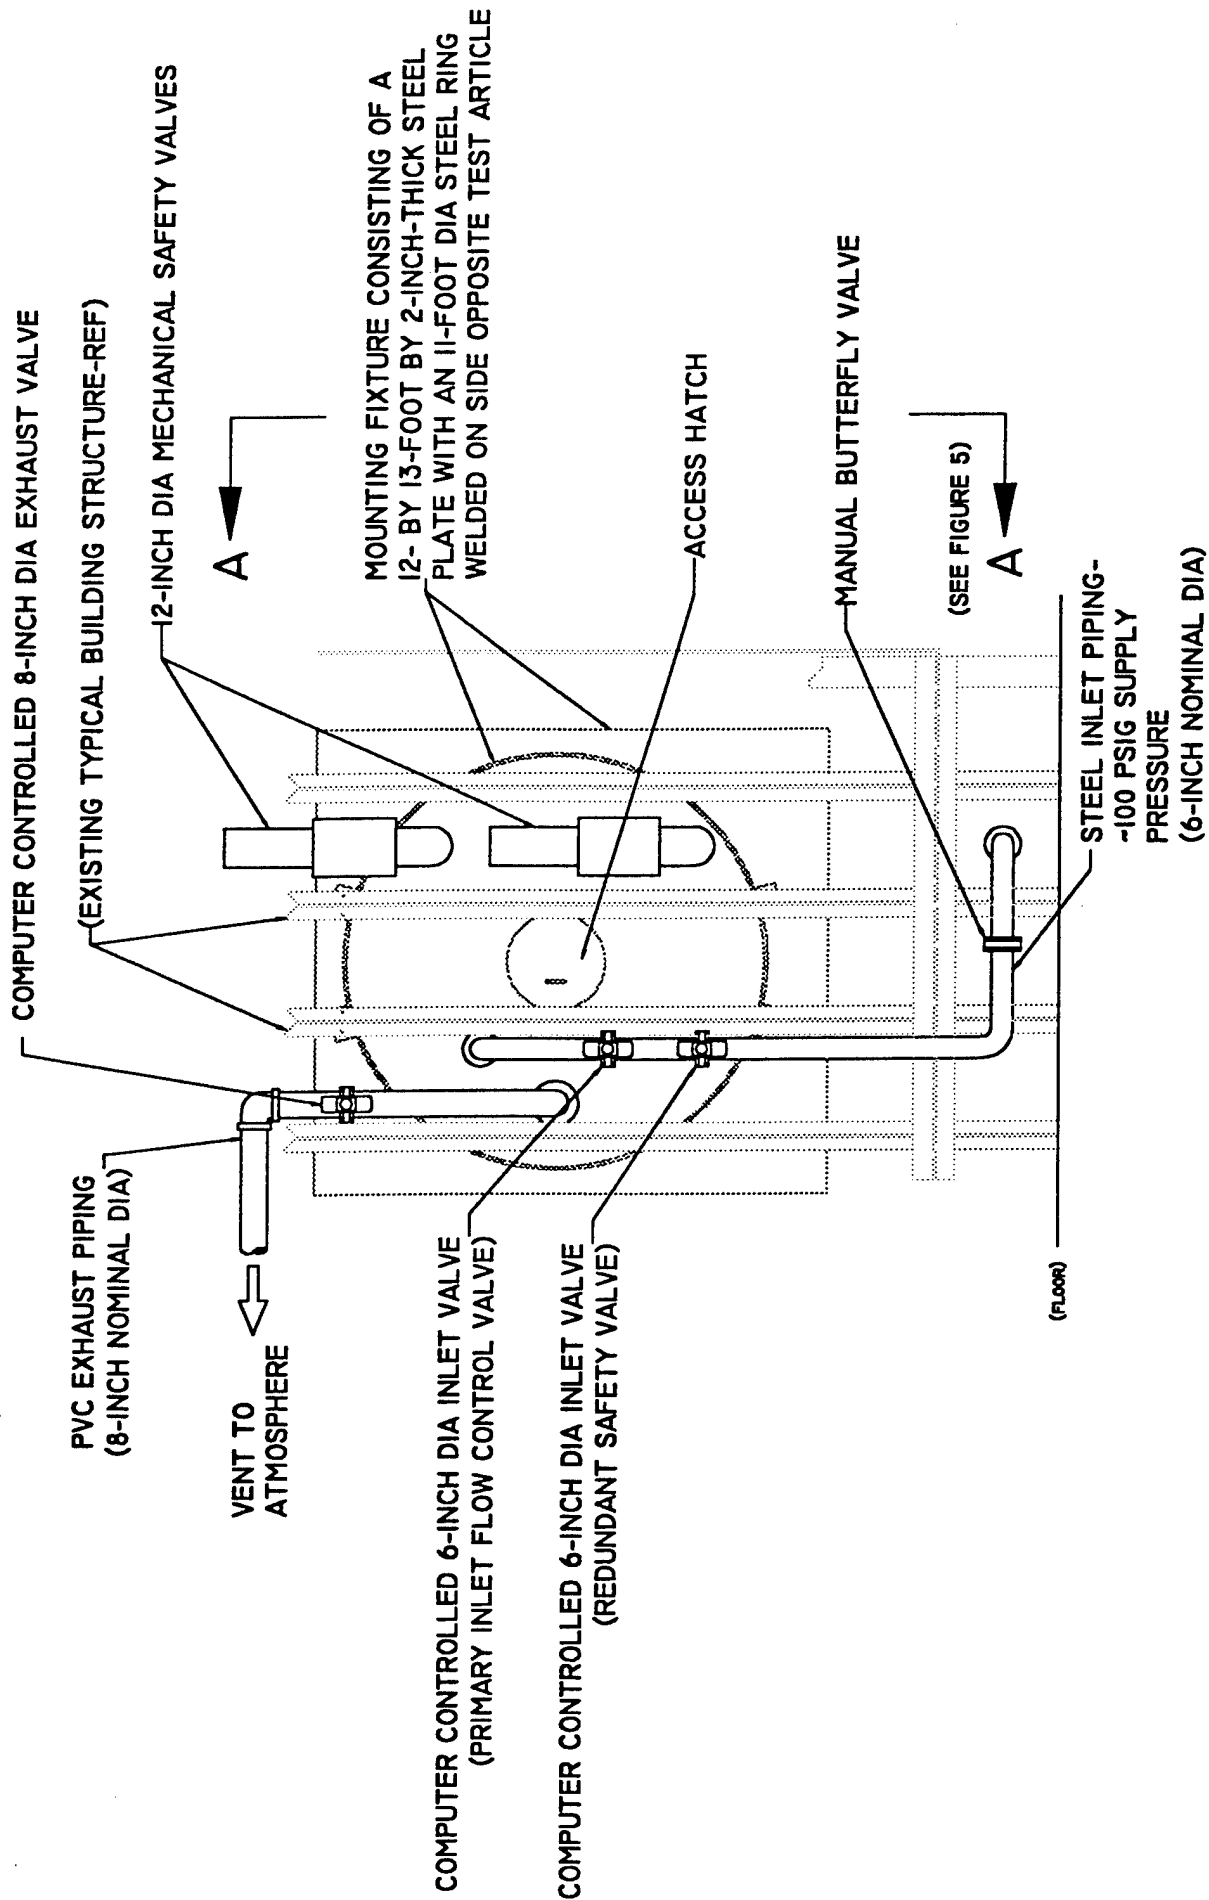
Figure 4. Test Setup, Front View

In this program, the aforementioned DC-9 fuselage section was fastened to the mounting fixture. This fixture consisted of a 2-inch by 12- by 13-foot American Society for Testing and Materials (ASTM) A-36 steel plate with a 1-inch thick by 11-foot-diameter ASTM A-36 steel ring welded to the side opposite the test article. This ring had four brackets welded onto its periphery to mount the entire assembly to Building 65's existing test support structure using eight 3/4-inch-diameter bolts (AN12-27). Two 12-inch diameter mechanical safety valves, the 6-inch-diameter inlet port, the 8-inch-diameter outlet port, various data and power feed-throughs, and a hinged access hatch were also incorporated into the plate. The test article was mounted via 360 3/8-inch diameter Society of Automotive Engineers (SAE) grade 5 bolts. These fasteners clamped the fuselage transition structure installed by Boeing to the 2-inch-thick steel mounting plate. To minimize air pressure loss, the fasteners passing through to the inside of the test article were installed wet with Dow Corning 733 RTV Sealant. The pilot holes for these fasteners were drilled in the test article transition structure by Boeing-Long Beach. These hole locations were then transferred to the mounting plate and drilled and tapped as necessary.

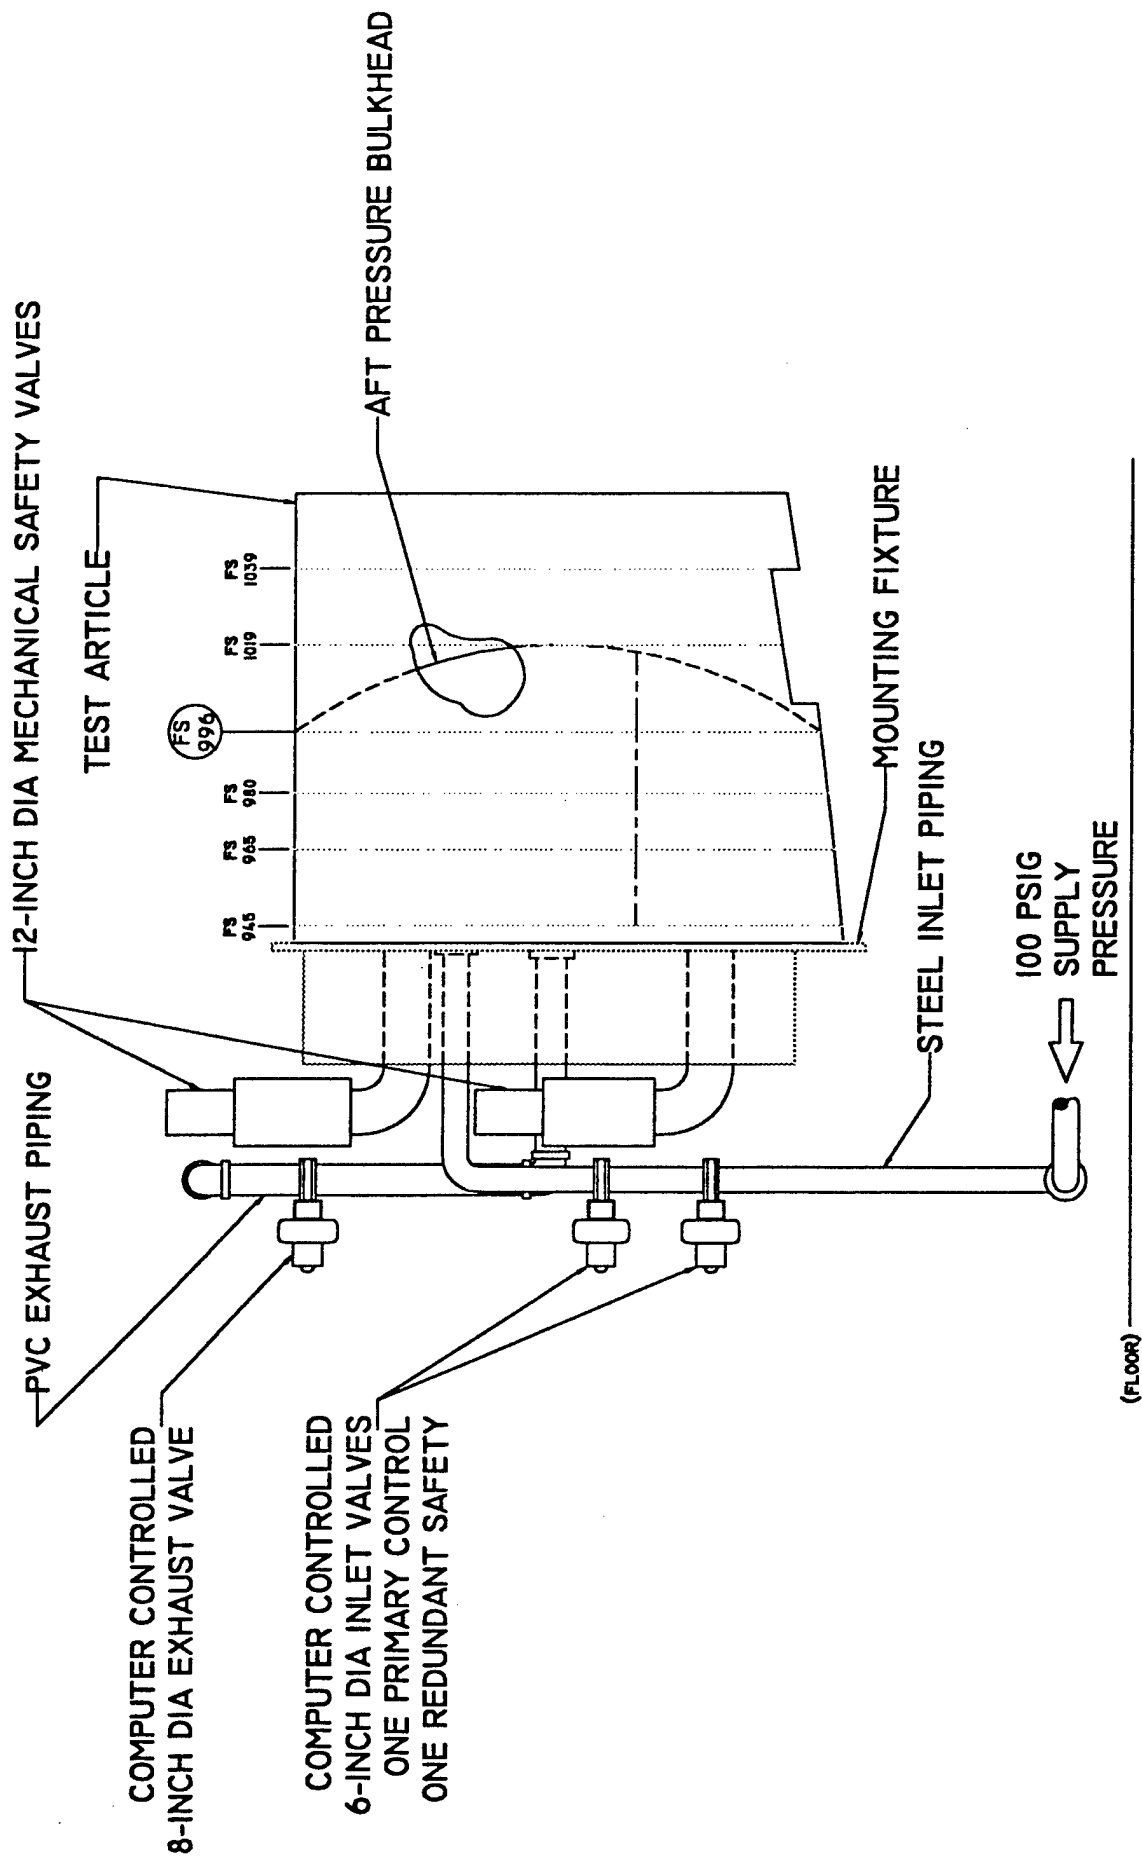
**Figure 5. Test Setup, Side View**

**VIEW A-A (SEE FIGURE 4)**  
 (NOTE: EXISTING BUILDING STRUCTURE NOT SHOWN FOR CLARITY)

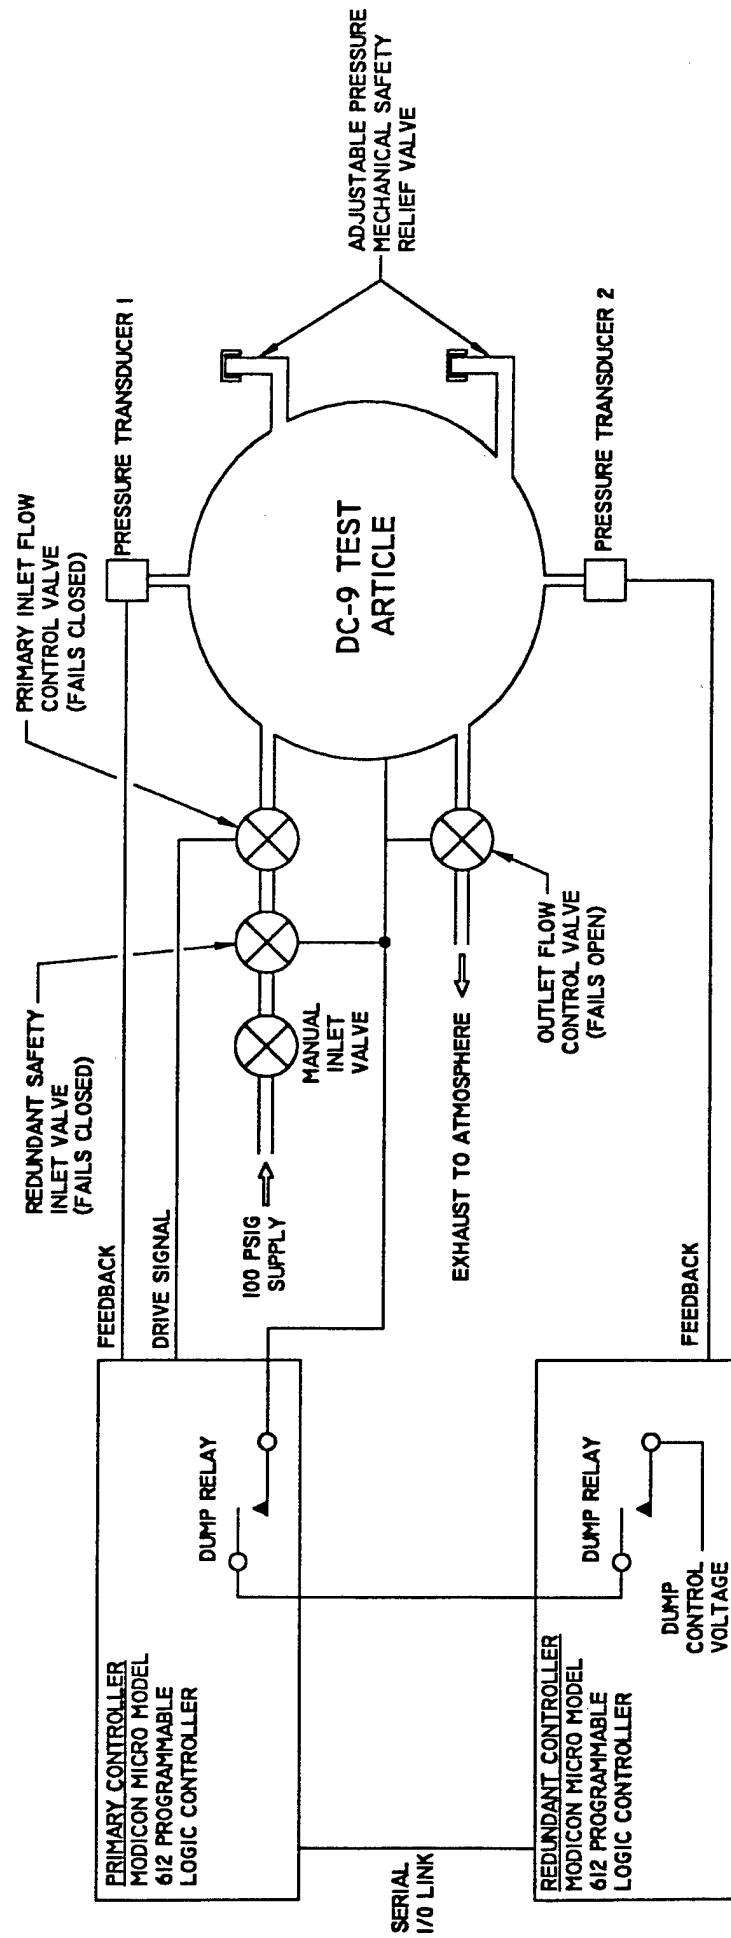
Figure 6. Test Control System Schematic

Refer to figure 6. Two Modicon Micro Model 612 programmable logic controllers (one primary, one redundant) were utilized for this test. The primary controller used the feedback from one of the pressure transducers in generating the drive signal to the 6-inch-diameter primary inlet valve. During normal operation, this controller would close the 8-inch-diameter exhaust valve, fully open the redundant 6-inch-diameter inlet valve, and modulate the primary inlet valve to achieve a haversine pressure versus time profile within the test article. Once the specified upper pressure limit was attained, the controller would close both primary and redundant inlet valves and open the exhaust valve until the lower pressure limit was achieved. The cycle would then repeat as necessary.

The second redundant controller was linked in series to the primary controller and sampled the feedback from a different pressure transducer. The primary program signal and step number were sent to the redundant controller over the serial I/O link. The redundant controller used the step number to calculate the expected program signal. The expected and primary program signals were compared (program signal verification). If the two did not match, the test was dumped by the redundant. Bits were toggled between the primary and redundant over the serial I/O link. If the bits stopped toggling for 50 ms, the test would be dumped by either controller.

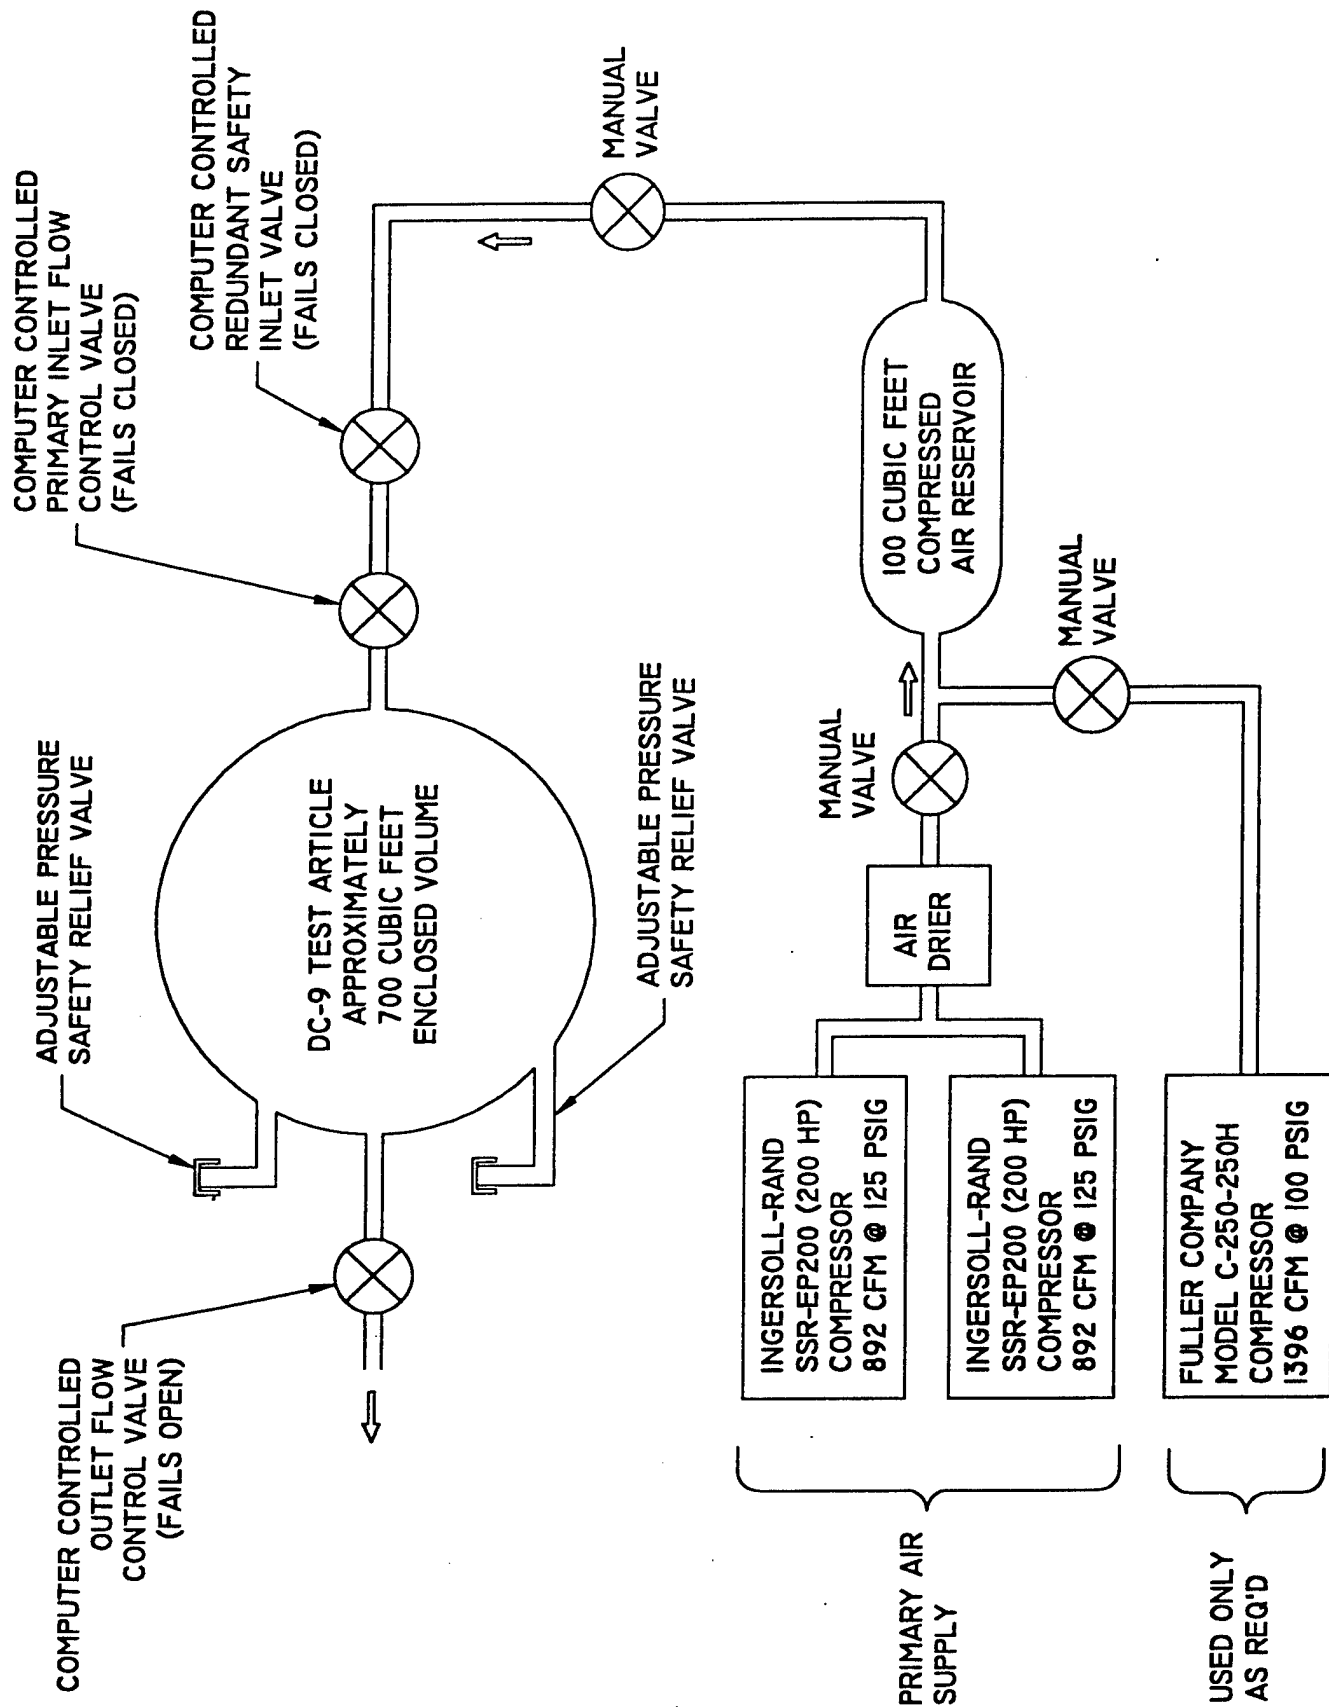
Figure 7. Test Pneumatic System Schematic

Refer to figure 7. The shop air system at Building 65 consisted of two Ingersoll-Rand SSR-EP200 (200 HP) air compressors with a nominal output of 892 cubic feet per minute (CFM) @ 125 psi each. These fed a 100  $\text{ft}^3$  accumulator via a filter/drier unit. Air inlet to the test article was accomplished by a 6-inch-diameter, schedule 40 steel airline from the accumulator to the 2-inch-thick mounting plate. In this airline, two electronically controlled, pneumatically operated, 6-inch-diameter butterfly valves were placed in series. One of these was the primary inlet flow control valve while the second one was used as a redundant safety valve. These inlet valves were sized based on the preliminary understanding that the test article would have an enclosed volume of approximately 2000  $\text{ft}^3$ . They were ordered and received prior to the delivery of the test article, which actually had a volume nearer to 700  $\text{ft}^3$ .

These Flowserve Corp. Automax valves are normally closed. In the event of an electrical power loss or pneumatic control failure, these valves would automatically return to a closed position, thus shutting off the inlet air supply. The electronically controlled, pneumatically operated, 8-inch-diameter butterfly outlet valve was plumbed to exhaust the test article air up and away from the test control center. This Flowserve Corp. Automax valve is normally open. In the event of an electrical power loss or pneumatic control failure, this valve would automatically return to an open position, thus releasing all pressure from the test article. Eight-inch-diameter, schedule 40 polyvinyl chloride (PVC) pipe was used for the exhaust line. Two short, 12-inch-diameter steel lines were used with calibrated weights as mechanical safety valves. These weights were adjustable to permit variable pressures within the test article.

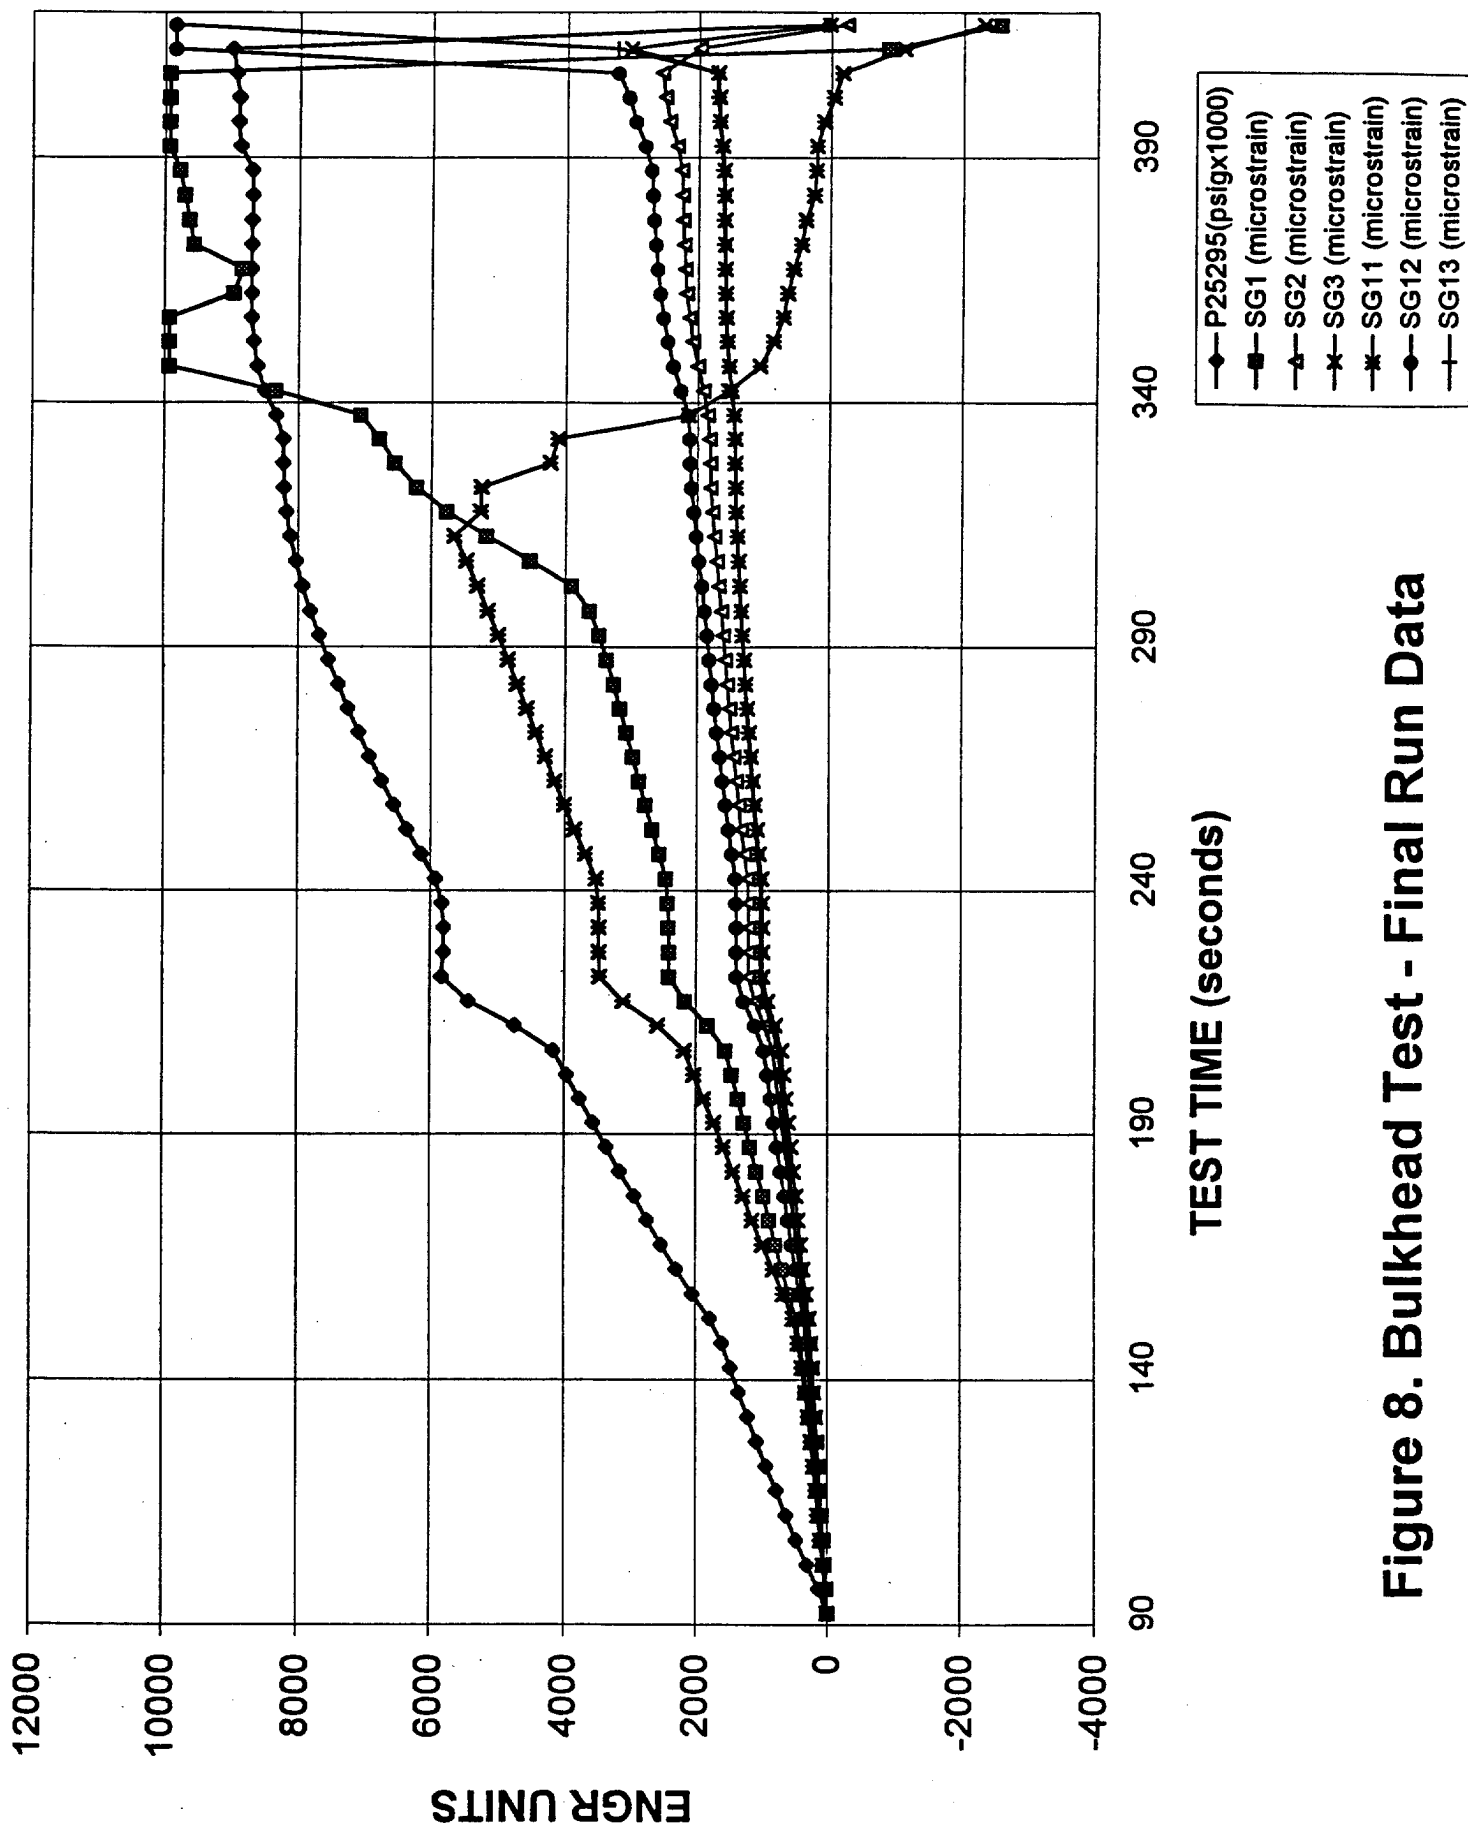
Figure 8. Bulkhead Test - Final Run Data

As evident from Table 1 and by the graphs in Figures 8 and 9, up to a test time of approximately 300 seconds at a pressure of 7.94 psig, strain gages SG1, SG2, SG3,

SG11, SG12, and SG13 recorded a strain level mirroring test article pressure. These strain gages are of particular interest since SG1 through SG3 were in sequential order from the top end of the lead crack tip and SG11 through SG13 were in sequential order from the bottom end of the lead crack tip. At a test time of approximately 300 seconds, the output of SG1 indicated a strain level rising much quicker than the test article pressure. Approximately 10 seconds later at a pressure of 8.11 psig, SG11 reached its maximum value and failed. Gage SG1 failed at 407.45. The final bulkhead failure sequence began at time 408.80 at a pressure of 8.99 psig when SG12 began a rapid rise, followed by SG2 at time 408.90. At test time 409.95, SG2 failed and the upper lead crack tip extended to the next rivet hole, followed rapidly by SG3 and SG13 at 410.10. At test time 410.15, the test article pressure began to fall as the crack extended and vented the compressed air faster than the control system could accommodate the loss. Finally, at test time 410.20, the pressure dropped rapidly, indicating total failure of the bulkhead structure.
